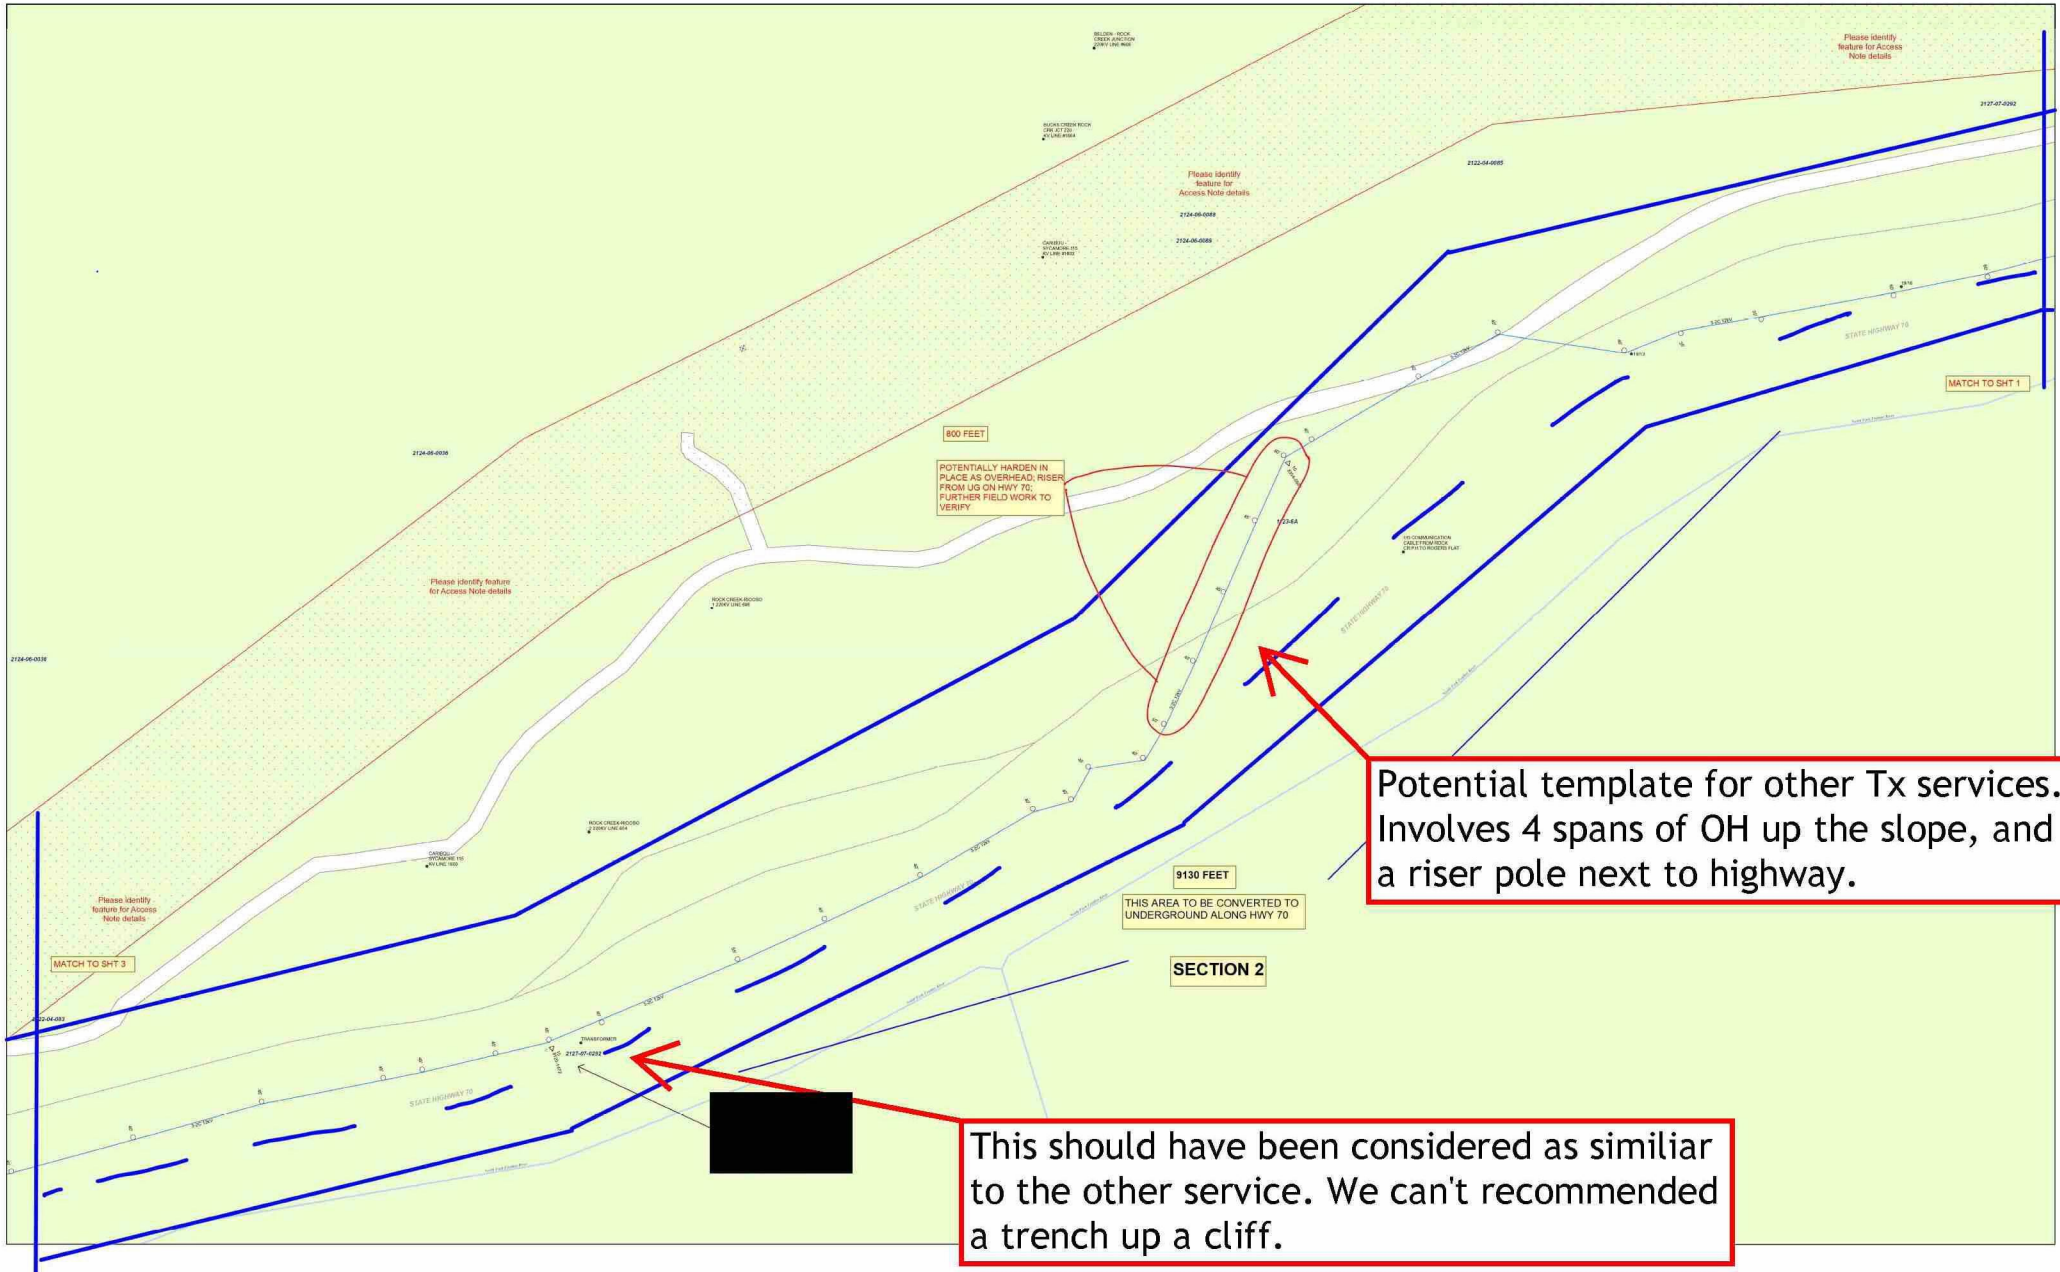
This should have been considered as similar to the other service. We can't recommended a trench up a cliff.

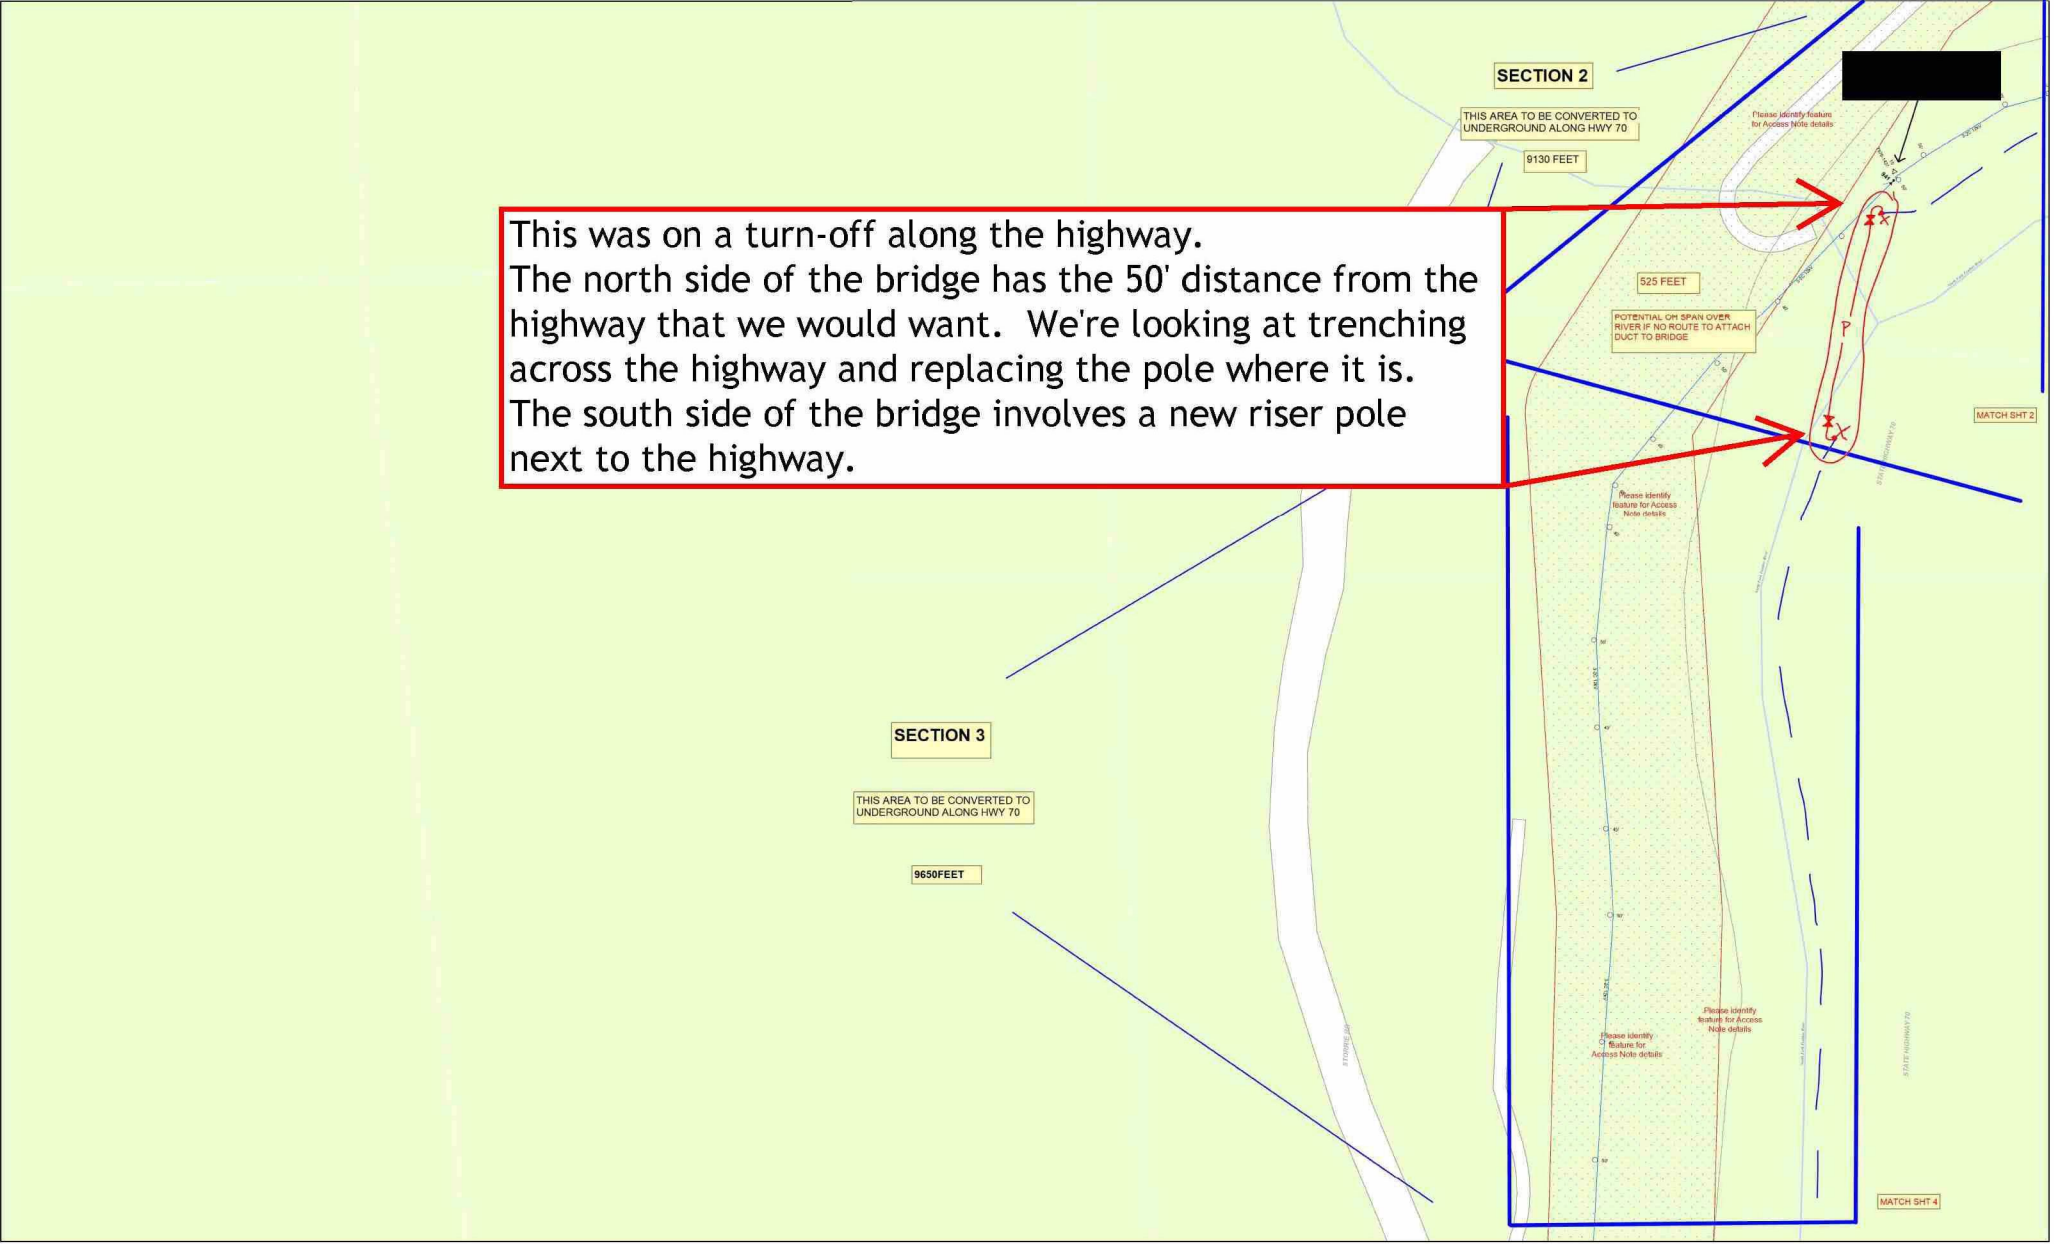
This was on a turn-off along the highway.  
The north side of the bridge has the 50' distance from the  
highway that we would want. We're looking at trenching  
across the highway and replacing the pole where it is.  
The south side of the bridge involves a new riser pole  
next to the highway.
