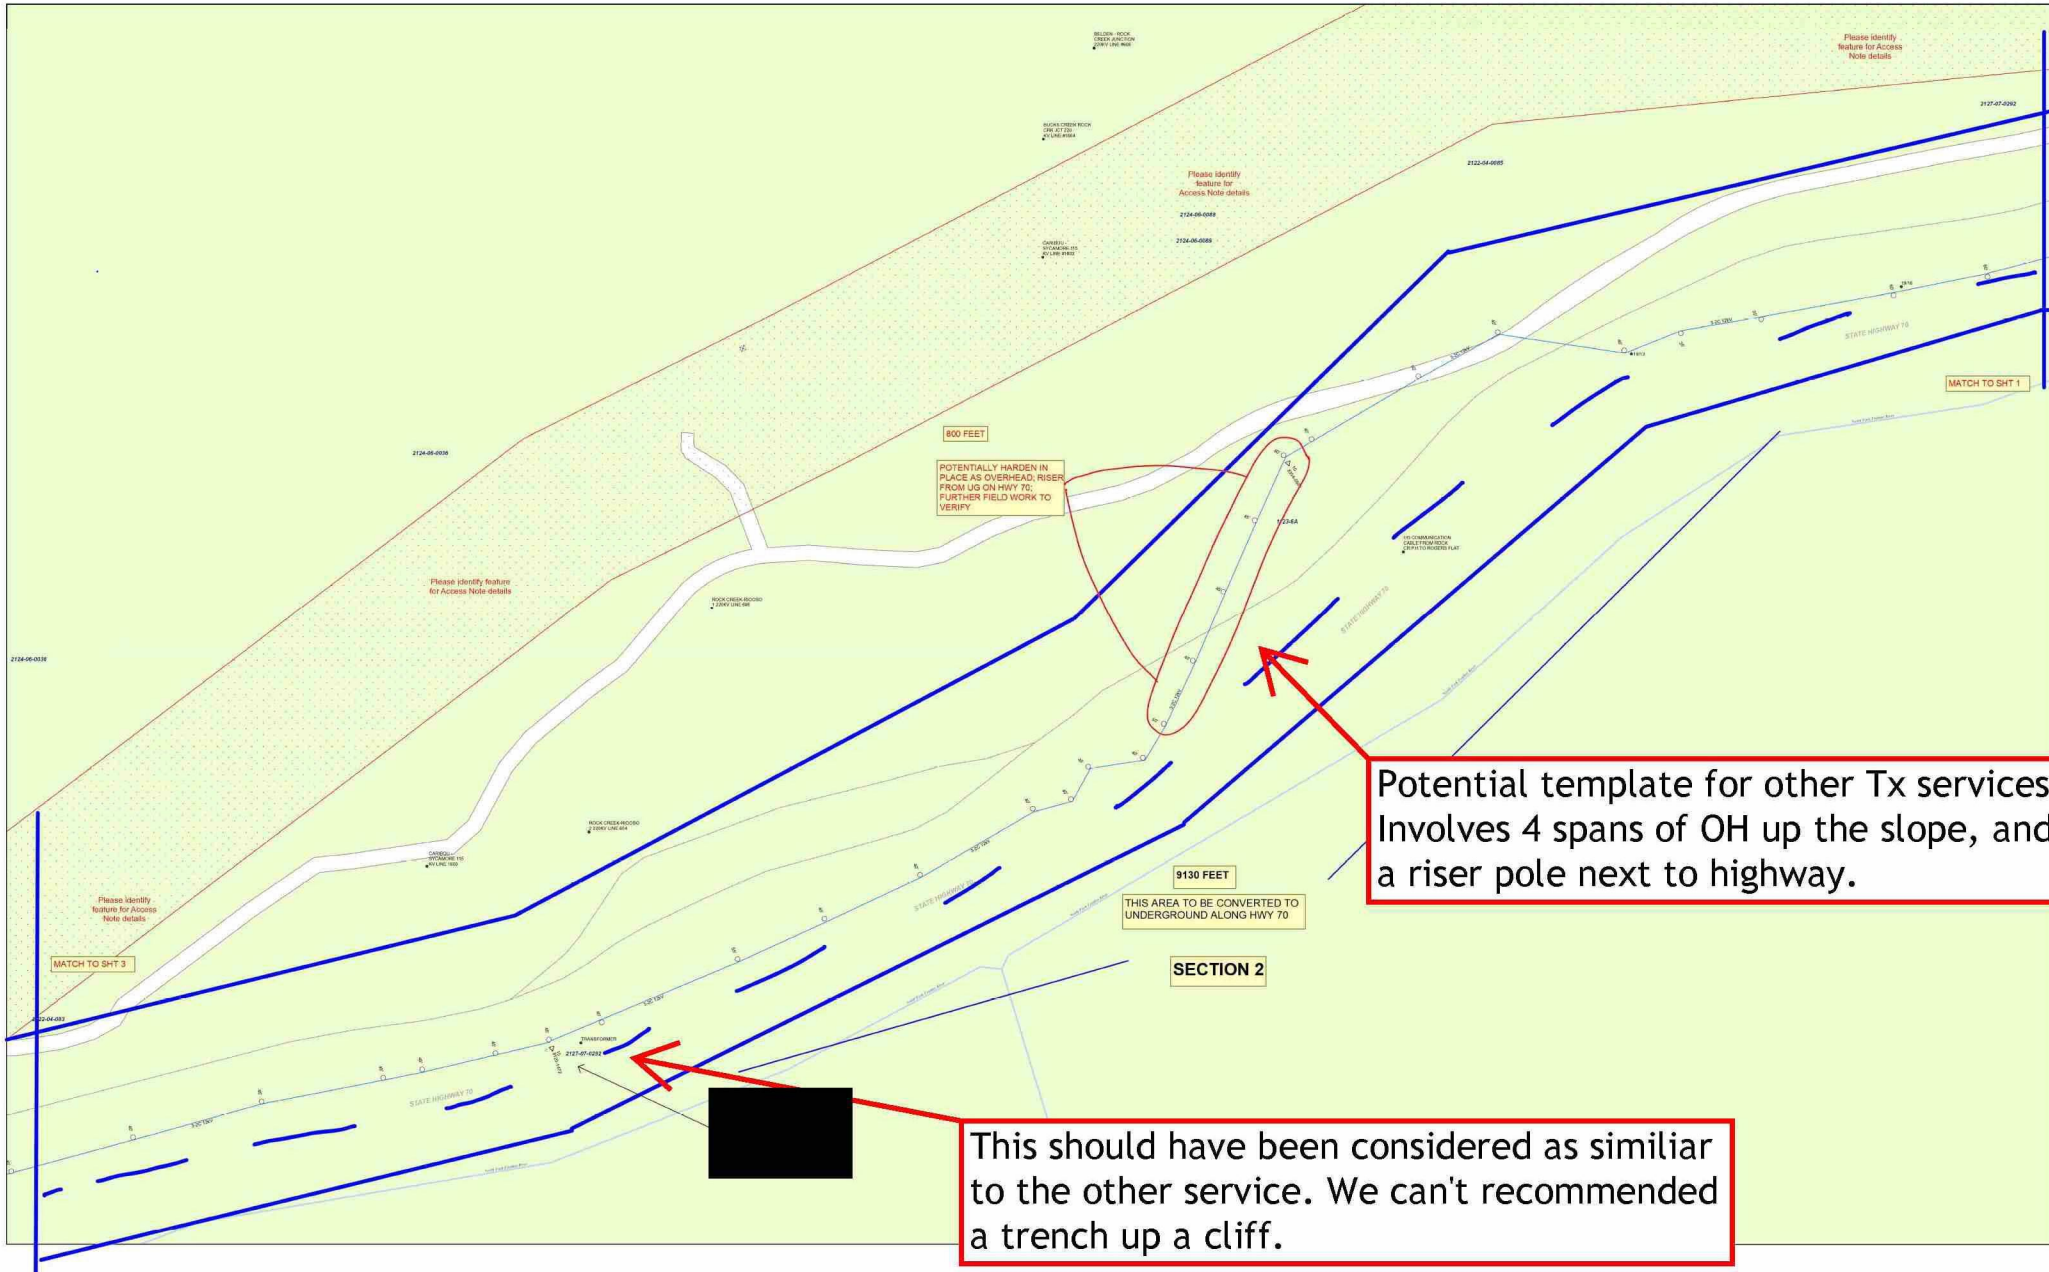
This should have been considered as similar to the other service. We can't recommended a trench up a cliff.

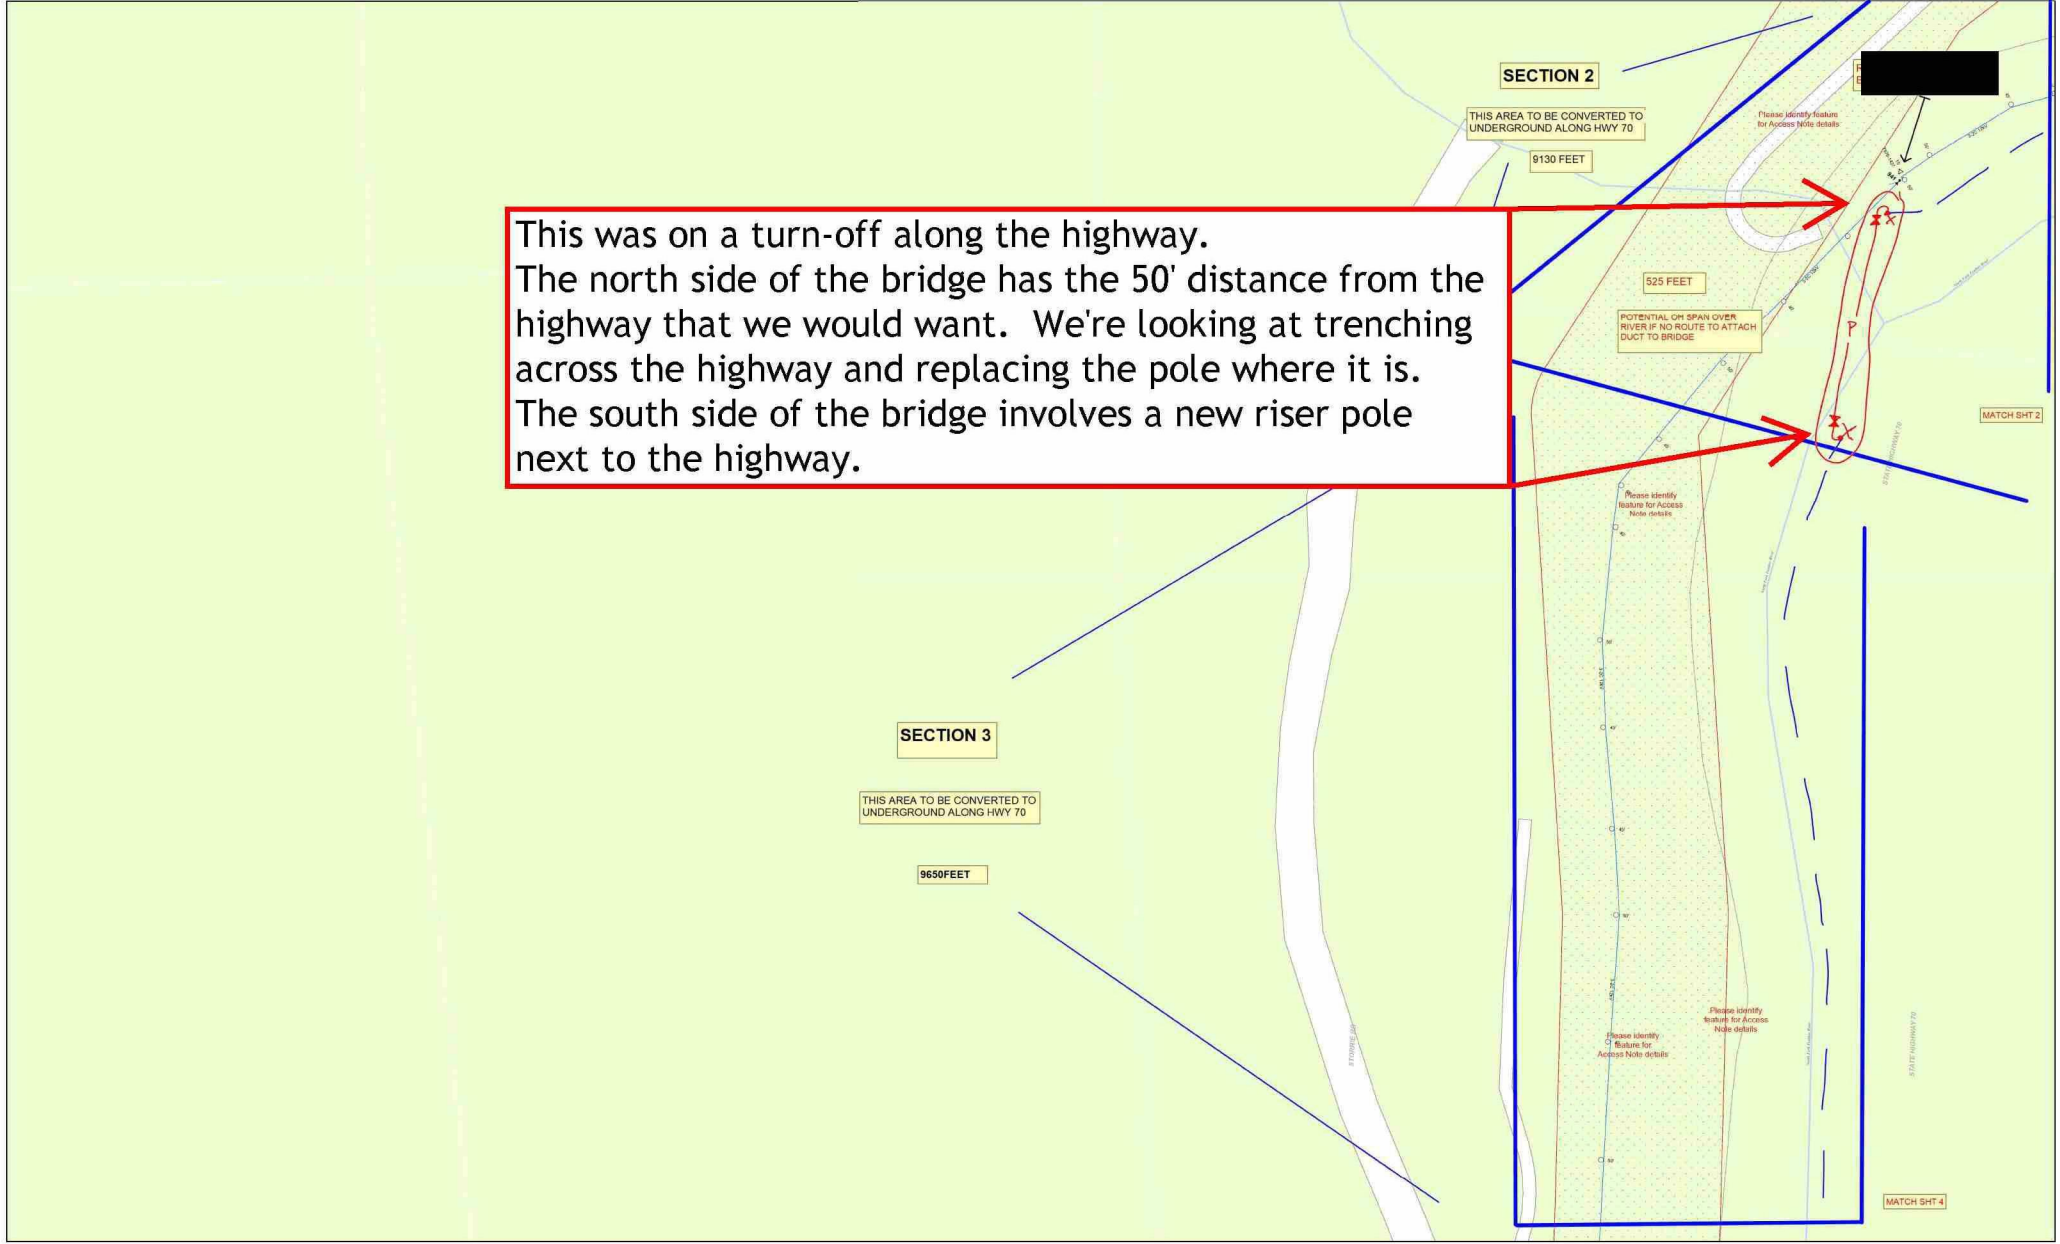
This was on a turn-off along the highway.
The north side of the bridge has the 50' distance from the highway that we would want. We're looking at trenching across the highway and replacing the pole where it is. The south side of the bridge involves a new riser pole next to the highway.
