Bucks PH Outage 2020 Daily Status Report 07/14/2021

Bucks PH Outage 2020 Daily Status Report: July 14, 2021

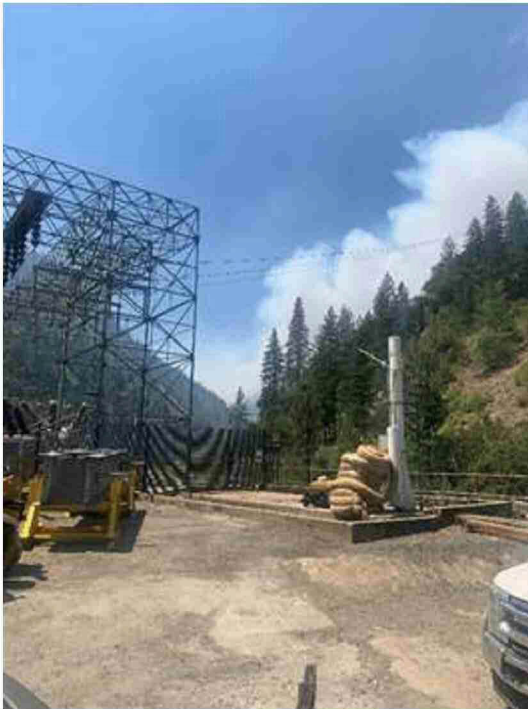
- The Dixie Fire is uncomfortably close to Bucks PH. With variable wind direction all day, the rapid growth

of the fire, and the increasing intensity of smoke; the outage manager made the decision to stop work for the day and send everyone down the hill before Hwy 70 closed.

^Dixie Fire

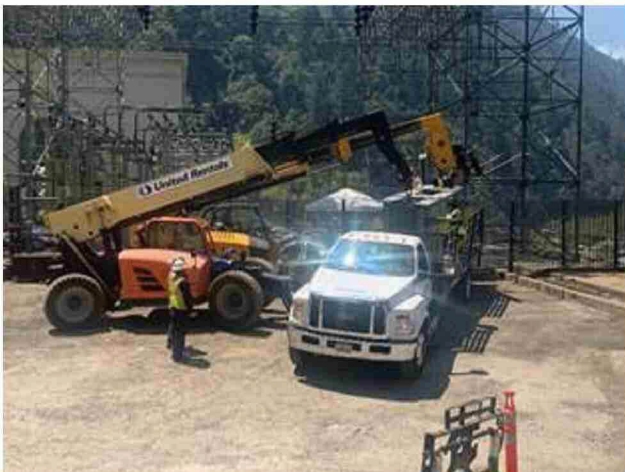
^Relocating Spreader Beam to Powerhouse
