Subject: Bucks PH Outage 2020 Daily Status Report 07/14/2021

Bucks PH Outage 2020 Daily Status Report: July 14, 2021

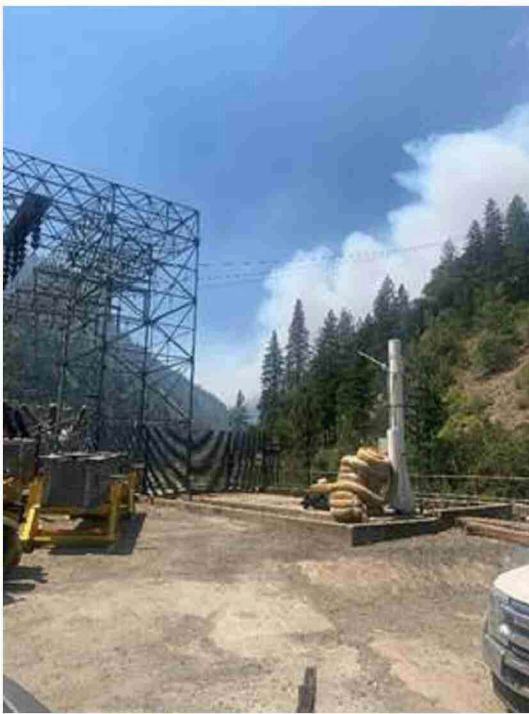
- The Dixie Fire is uncomfortably close to Bucks PH. With variable wind direction all day, the rapid growth of the fire, and the increasing intensity of smoke; the outage manager made the decision to stop work for the day and send everyone down the hill before Hwy 70 closed.
- Rotor Repair - CAP [121625142](#) – repair contractor mobilizing under FCA, contract in routing. GC removing removable hub.
- Need to decide the method of removing the shaft & rotor from the unit. TCB submitted two different lift plans for review. This is being worked on by engineering an TCB.
- Several documents are needed before TCB can begin their scope in the rotor repair process.
 - Executed contract (routing)
 - Approved Site Specific Safety Plan (routing)
 - Approved Quality Plan (in development)
 - Approved Lift Plan (under review)
 - Night Inspector (need estimated start date)

^Dixie Fire

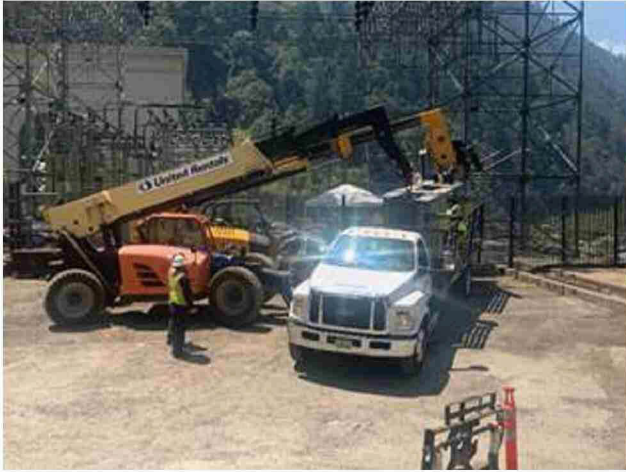
^Relocating Spreader Beam to Powerhouse
