Bucks PH Outage 2020 Daily Status Report 07/14/2021

**Bucks PH Outage 2020 Daily Status Report: July 14, 2021**

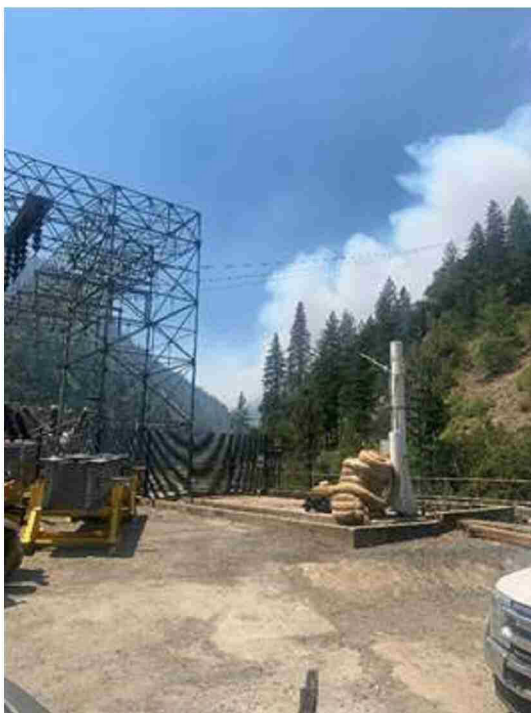
- The Dixie Fire is uncomfortably close to Bucks PH. With variable wind direction all day, the rapid growth

of the fire, and the increasing intensity of smoke; the outage manager made the decision to stop work for the day and send everyone down the hill before Hwy 70 closed.

^Dixie Fire

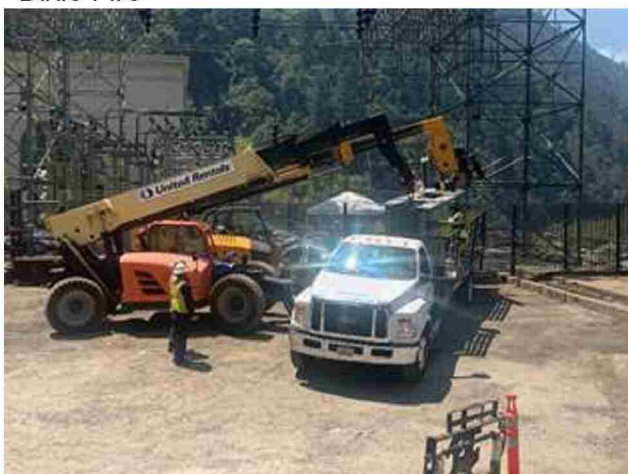
^Relocating Spreader Beam to Powerhouse
