Subject: Bucks PH Outage 2020 Daily Status Report 07/14/2021

Bucks PH Outage 2020 Daily Status Report: July 14, 2021

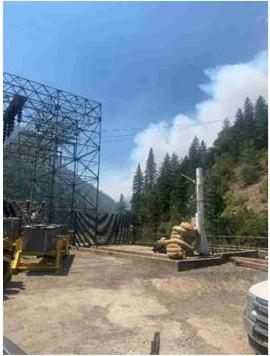
- The Dixie Fire is uncomfortably close to Bucks PH. With variable wind direction all day, the rapid growth of the fire, and the increasing intensity of smoke; the outage manager made the decision to stop work for the day and send everyone down the hill before Hwy 70 closed.
- Rotor Repair CAP <u>121625142</u> repair contractor mobilizing under FCA, contract in routing. GC removing removable hub.
- Need to decide the method of removing the shaft & rotor from the unit. TCB submitted two different lift plans for review. This is being worked on by engineering an TCB.
- Several documents are needed before TCB can begin their scope in the rotor repair process.
 - Executed contract (routing)
 - o Approved Site Specific Safety Plan (routing)
 - Approved Quality Plan (in development)
 - Approved Lift Plan (under review)
 - Night Inspector (need estimated start date

^Dixie Fire
