20210628-18193523042
Electric Drone SubStations Missing Asset - Approver 2021

SUBSTATION FORM

Station: CRESTA PH
Head Quarter: Table Mountain
Date Inspected: Jun 28, 2021 11:58:00 AM PDT
Inspected By: [Redacted]

Asset Type: ETS.TXFR
Equipment: BANK 1 A PH
Is this a Re-Inspection Form?: No

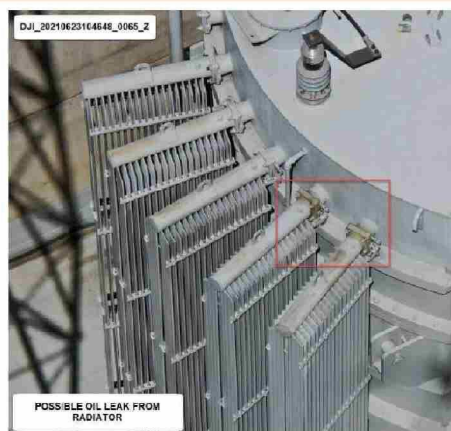
Any signs of leaks? Yes
Additional consideration may be required for this finding

↳ Describe Issue: ↳ POSSIBLE OIL LEAK

Please select all that apply Seeping

Problem Description	BK 1 A OIL LEAK
Facility/Equipment Type	Transformer/Regulator
Damage	Leaks
Action	Repair
Priority	B
Required End Date	2021-09-26
Identified in Field During	Station Inspection-DDSI
Clearance Required	Yes
Crew Class (Size)	SUB_ELE2
Est Hours	10
Est. Total Job Costs to Complete in Hrs (labor,materials,rentals, etc. - no travel time)	20
FIELD COMMENTS (Describe the work required and the equipment and the materials needed. For example: Special tools or equipment, any unusual conditions, special circumstances and supporting comments related to other information required)	BK 1 A OIL LEAKS
Select Tier	T3 Drone Inspection
ETS Type	ETS51 Repair & Return

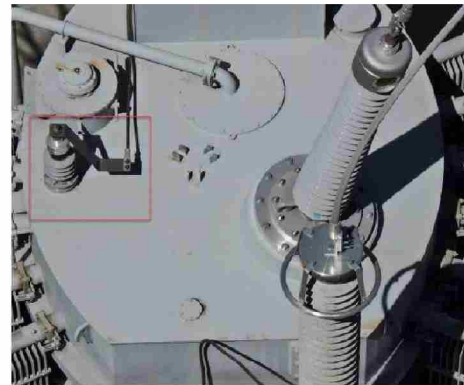
Is the H0 bushing of a lower voltage class than the H bushings? Yes

↳ Describe Issue: ↳ VISIBLY SMALLER

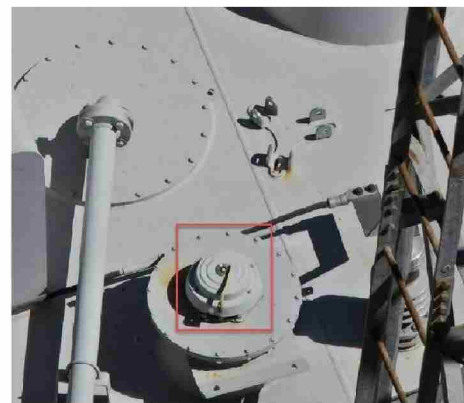
Is there indication of pressure relief device activation? No

↳ Describe Issue:

↳ FLAG OUT OF ALIGNMENT

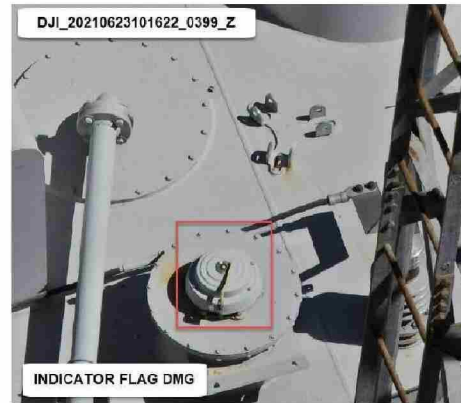
Is pressure relief device actuation flag damaged? Yes

↳ Describe Issue:

↳ FLAG OUT OF ALIGNMENT

Problem Description	BK 1 A PRD FLAG OFFSET
Facility/Equipment	Transformer/Regulator
Type	LTCR
Damage	Damaged
Action	Repair
Priority	B
Required End Date	2021-09-26
Identified in Field During	Station Inspection-DDSI
Clearance Required	Yes
Crew Class (Size)	SUB_ELE2
