20210628-18193516111
Electric Drone SubStations Missing Asset - Approver 2021

SUBSTATION FORM

Station: CRESTA PH
Head Quarter: Table Mountain
Date Inspected: Jun 28, 2021 1:51:00 PM PDT
Inspected By: [Redacted]

Asset Type: ETS.TXFR
Equipment: BANK 1 B PH
Is this a Re-Inspection Form?: No

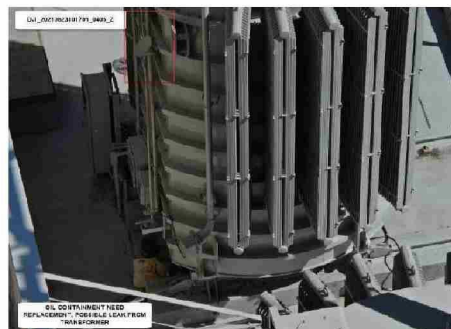
Any signs of leaks? **Yes**
Additional consideration may be required for this finding

↳ Describe Issue: **↳ POSSIBLE OIL LEAK, CONTAINMENT NEED REPLACEMENT**

Please select all that apply **Dripping**

Problem Description	BK 1 B PH OIL LEAK
Facility/Equipment	Transformer/Regulator
Type	Power TXFR
Damage	Leaks
Action	Repair
Priority	E
Required End Date	2022-06-28
Identified in Field During	Station Inspection-DDSI
Clearance Required	Yes
Crew Class (Size)	SUB_ELE2
Est Hours	10
Est. Total Job Costs to Complete in Hrs (labor,materials,rentals, etc. - no travel time)	20
FIELD COMMENTS (Describe the work required and the equipment and the materials needed. For example: Special tools or equipment, any unusual conditions, special circumstances and supporting comments related to other information required)	BK 1 B PH OIL LEAK. CHANGED TO PRIORITY E PER JOB AID. (MITIGATED)
Select Tier	T3 Drone Inspection
ETS Type	ETS51 Repair & Return

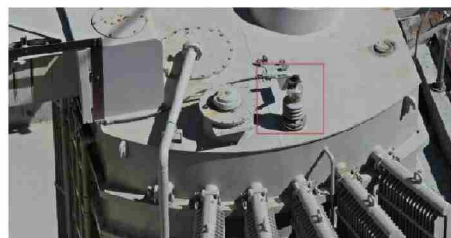
Is the high side neutral grounded? **Yes**

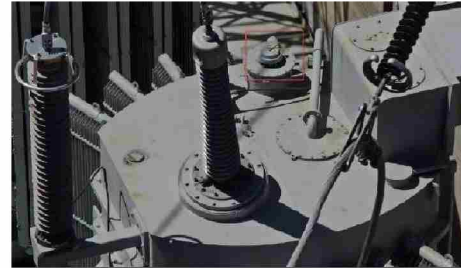
Pic Number: DJI_20210623101712_0407_Z
Are the radiators and cooling equipment in poor condition? No
Pic Number: DJI_20210623105852_0202_Z
Are the bushing connections in poor condition? No
Pic Number: DJI_20210623105852_0202_Z
Flash Mark Visible No
Pic Number: DJI_20210623104234_0020_Z
Does the transformer have PRD? Yes

Is there indication of pressure relief device activation? No

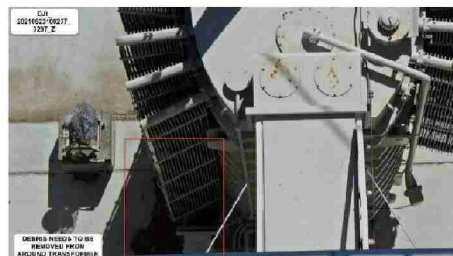
Were there any other findings for this asset ? (i.e... steel structures, cable risers, etc..) Yes
Additional consideration may be required for this finding

↳ Describe Issue: ↳ LEAVES/DEBRIS COLLECTED AROUND BASE OF TRANSFORMER
