20210628-18193523042
Electric Drone SubStations Missing Asset - Approver 2021

SUBSTATION FORM

Station: CRESTA PH
Head Quarter: Table Mountain
Date Inspected: Jun 28, 2021 11:58:00 AM PDT
Inspected By: [Redacted]

Asset Type: ETS.TXFR
Equipment: BANK 1 A PH
Is this a Re-Inspection Form?: No

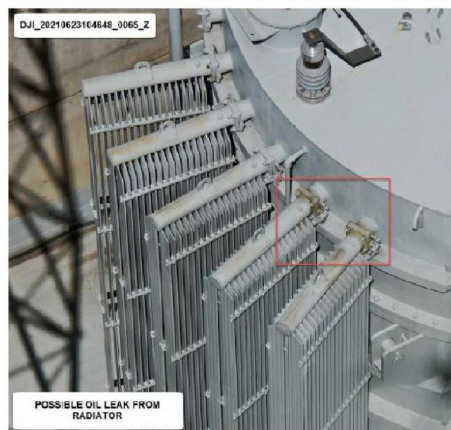
Any signs of leaks? Yes
Additional consideration may be required for this finding

↳ Describe Issue: ↳ POSSIBLE OIL LEAK

Please select all that apply Seeping

Problem Description	BK 1 A OIL LEAK
Facility/Equipment	Transformer/Regulator
Type	Power TXFR
Damage	Leaks
Action	Repair
Priority	B
Required End Date	2021-09-26
Identified in Field During	Station Inspection-DDSI
Clearance Required	Yes
Crew Class (Size)	SUB_ELE2
Est Hours	10
Est. Total Job Costs to Complete in Hrs (labor,materials,rentals, etc. - no travel time)	20
FIELD COMMENTS (Describe the work required and the equipment and the materials needed. For example: Special tools or equipment, any unusual conditions, special circumstances and supporting comments related to other information required)	BK 1 A OIL LEAKS
Select Tier	T3 Drone Inspection
ETS Type	ETS51 Repair & Return

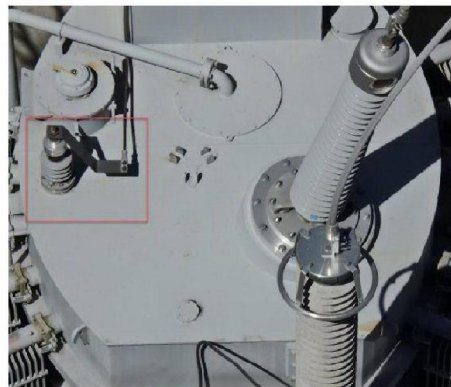
Is the high side neutral grounded? Yes

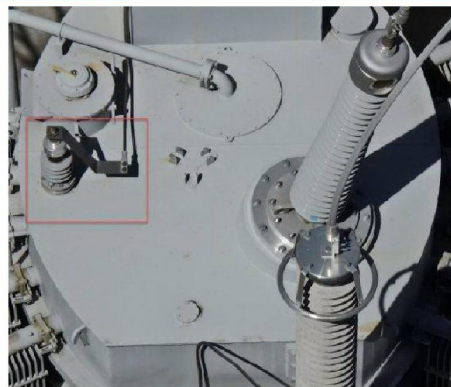
Is the H0 bushing of a lower voltage class than the H bushings? Yes

↳ Describe Issue: ↳ VISIBLY SMALLER

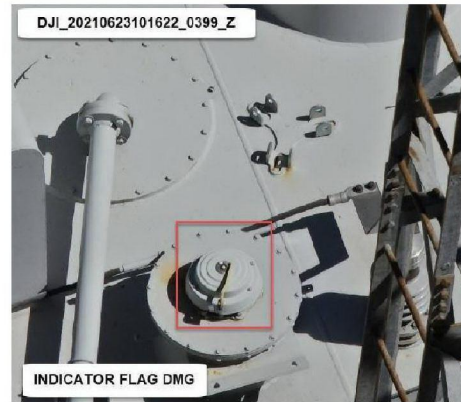
↳ FLAG OUT OF ALIGNMENT

Is pressure relief device actuation flag damaged? Yes

Problem Description	BK 1 A PRD FLAG OFFSET
Facility/Equipment	Transformer/Regulator
Type	LTCR
Damage	Damaged
Action	Repair
Priority	B
Required End Date	2021-09-26
Identified in Field During	Station Inspection-DDSI
Clearance Required	Yes
Crew Class (Size)	SUB_ELE2
