20210628-18193516111
Electric Drone SubStations Missing Asset - Approver 2021

SUBSTATION FORM

Station: CRESTA PH
Head Quarter: Table Mountain
Date Inspected: Jun 28, 2021 1:51:00 PM PDT
Inspected By: [Redacted]

Asset Type: ETS.TXFR
Equipment: BANK 1 B PH
Is this a Re-Inspection Form?: No

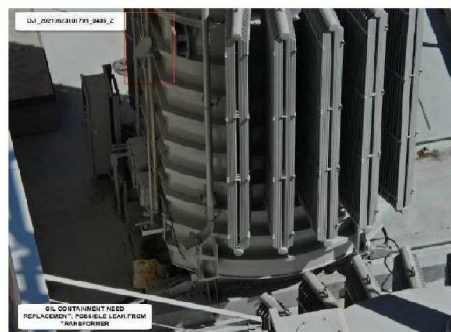
Any signs of leaks? **Yes**
Additional consideration may be required for this finding

↳ Describe Issue: **↳ POSSIBLE OIL LEAK, CONTAINMENT NEED REPLACEMENT**

Please select all that apply **Dripping**

Problem Description	BK 1 B PH OIL LEAK
Facility/Equipment	Transformer/Regulator
Type	Power TXFR
Damage	Leaks
Action	Repair
Priority	E
Required End Date	2022-06-28
Identified in Field During	Station Inspection-DDSI
Clearance Required	Yes
Crew Class (Size)	SUB_ELE2
Est Hours	10
Est. Total Job Costs to Complete in Hrs (labor,materials,rentals, etc. - no travel time)	20
FIELD COMMENTS (Describe the work required and the equipment and the materials needed. For example: Special tools or equipment, any unusual conditions, special circumstances and supporting comments related to other information required)	BK 1 B PH OIL LEAK. CHANGED TO PRIORITY E PER JOB AID. (MITIGATED)
Select Tier	T3 Drone Inspection
ETS Type	ETS51 Repair & Return

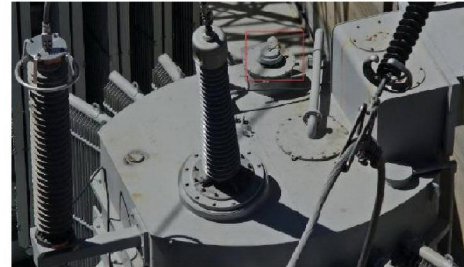
Is pressure relief device actuation flag damaged? Yes

↳ Describe Issue: ↳ PRD FLAG OUT OF ALIGNMENT

Problem Description	BK 1 B PH PRD FLAG OFFSET
Facility/Equipment	Transformer/Regulator
Type	LTCR
Damage	Damaged
Action	Repair
Priority	B
Required End Date	2021-09-26
Identified in Field During	Station Inspection-DDSI
Clearance Required	Yes
Crew Class (Size)	SUB_ELE2

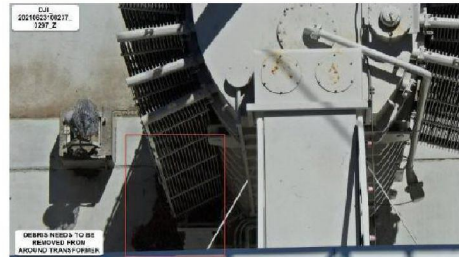
Were there any other findings for this asset ? (i.e... steel structures, cable risers, etc..) Yes
Additional consideration may be required for this finding

↳ Describe Issue: ↳ LEAVES/DEBRIS COLLECTED AROUND BASE OF TRANSFORMER
