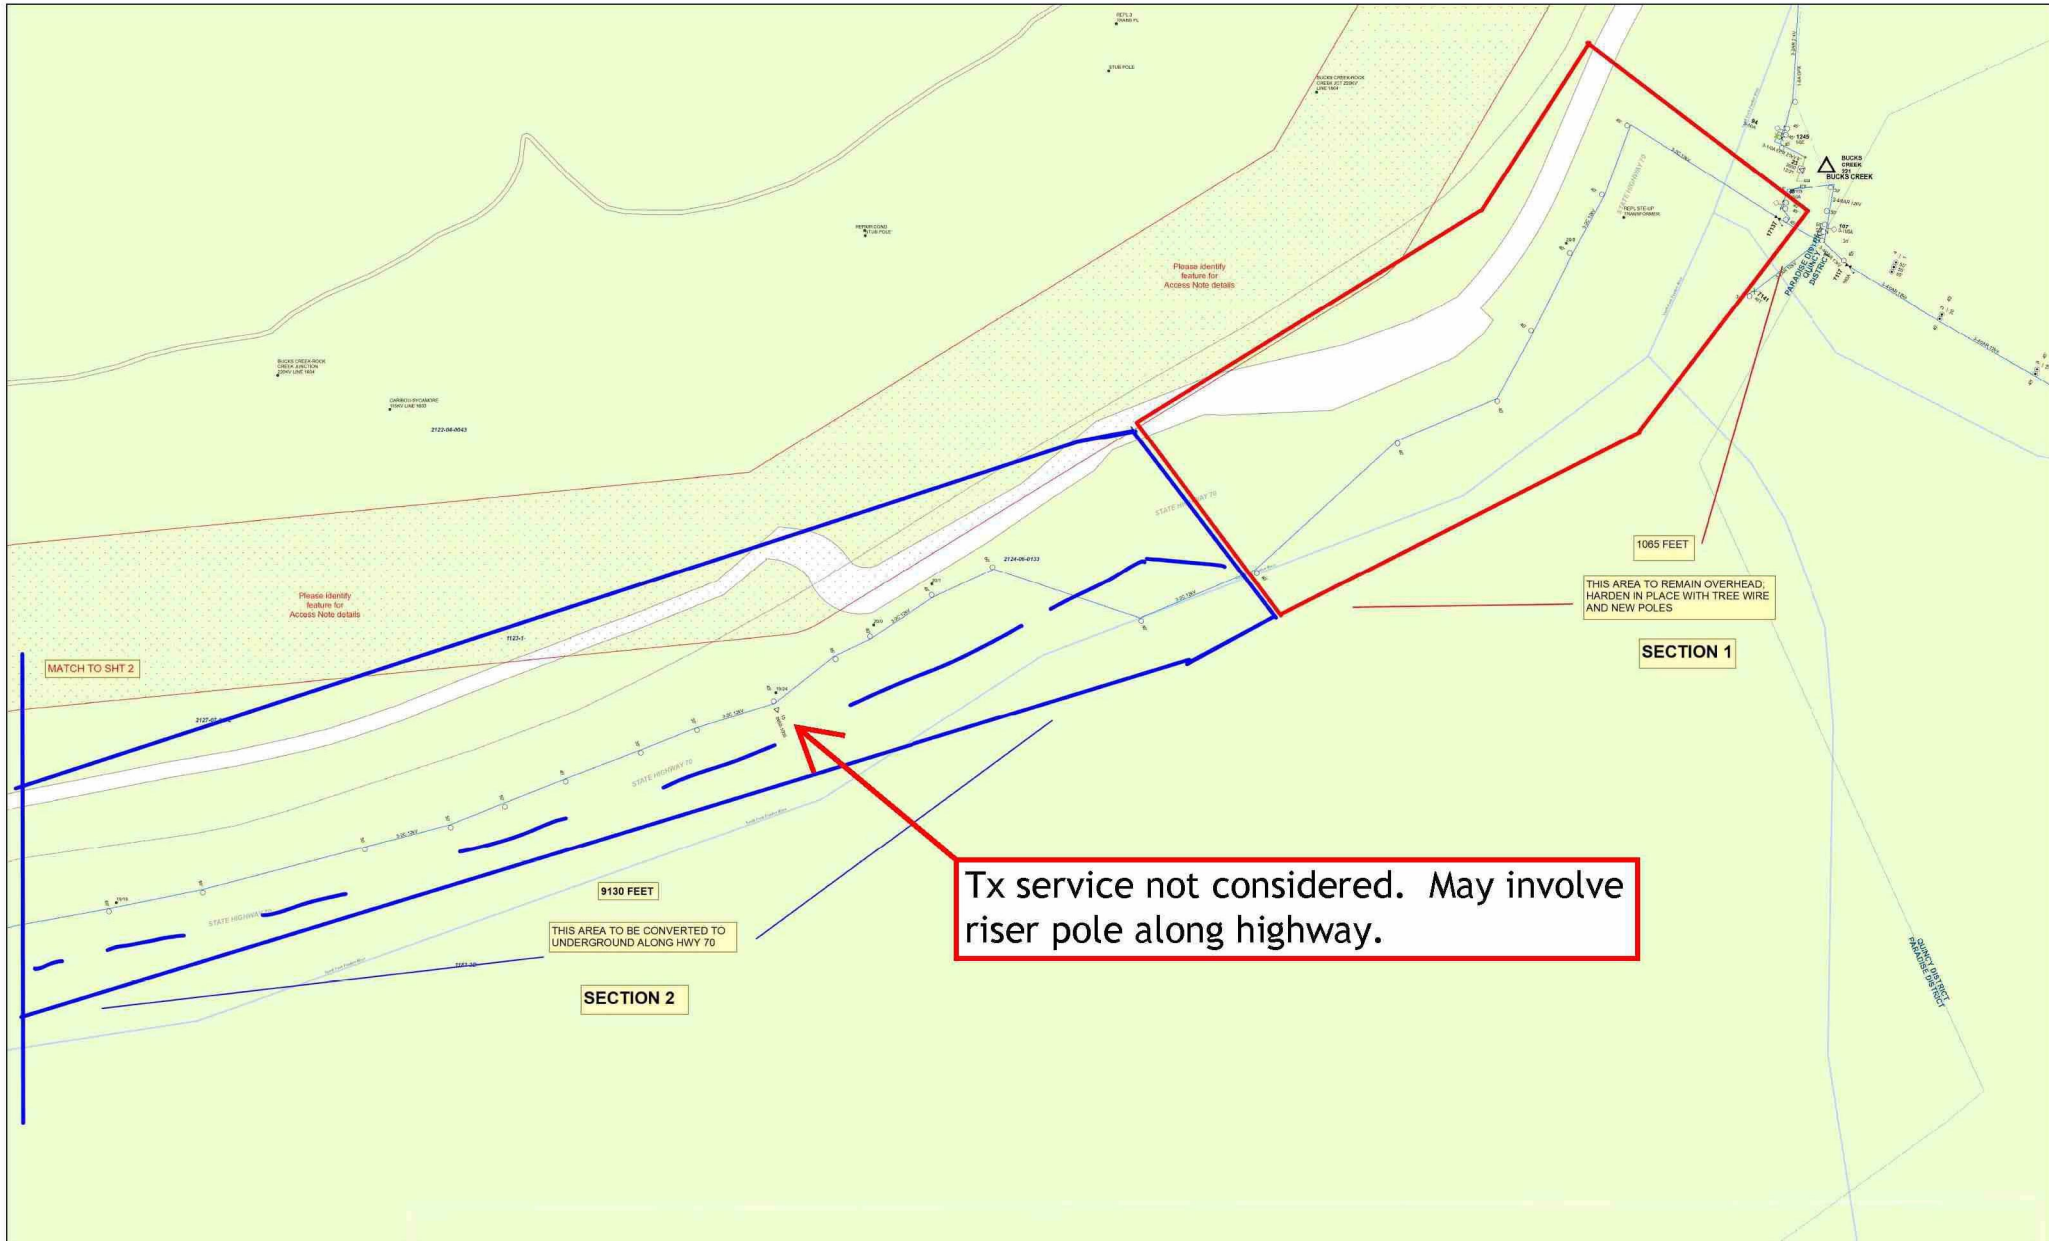
Potential template for other Tx services. Involves 4 spans of OH up the slope, and a riser pole next to highway.

This should have been considered as similar to the other service. We can't recommend a trench up a cliff.

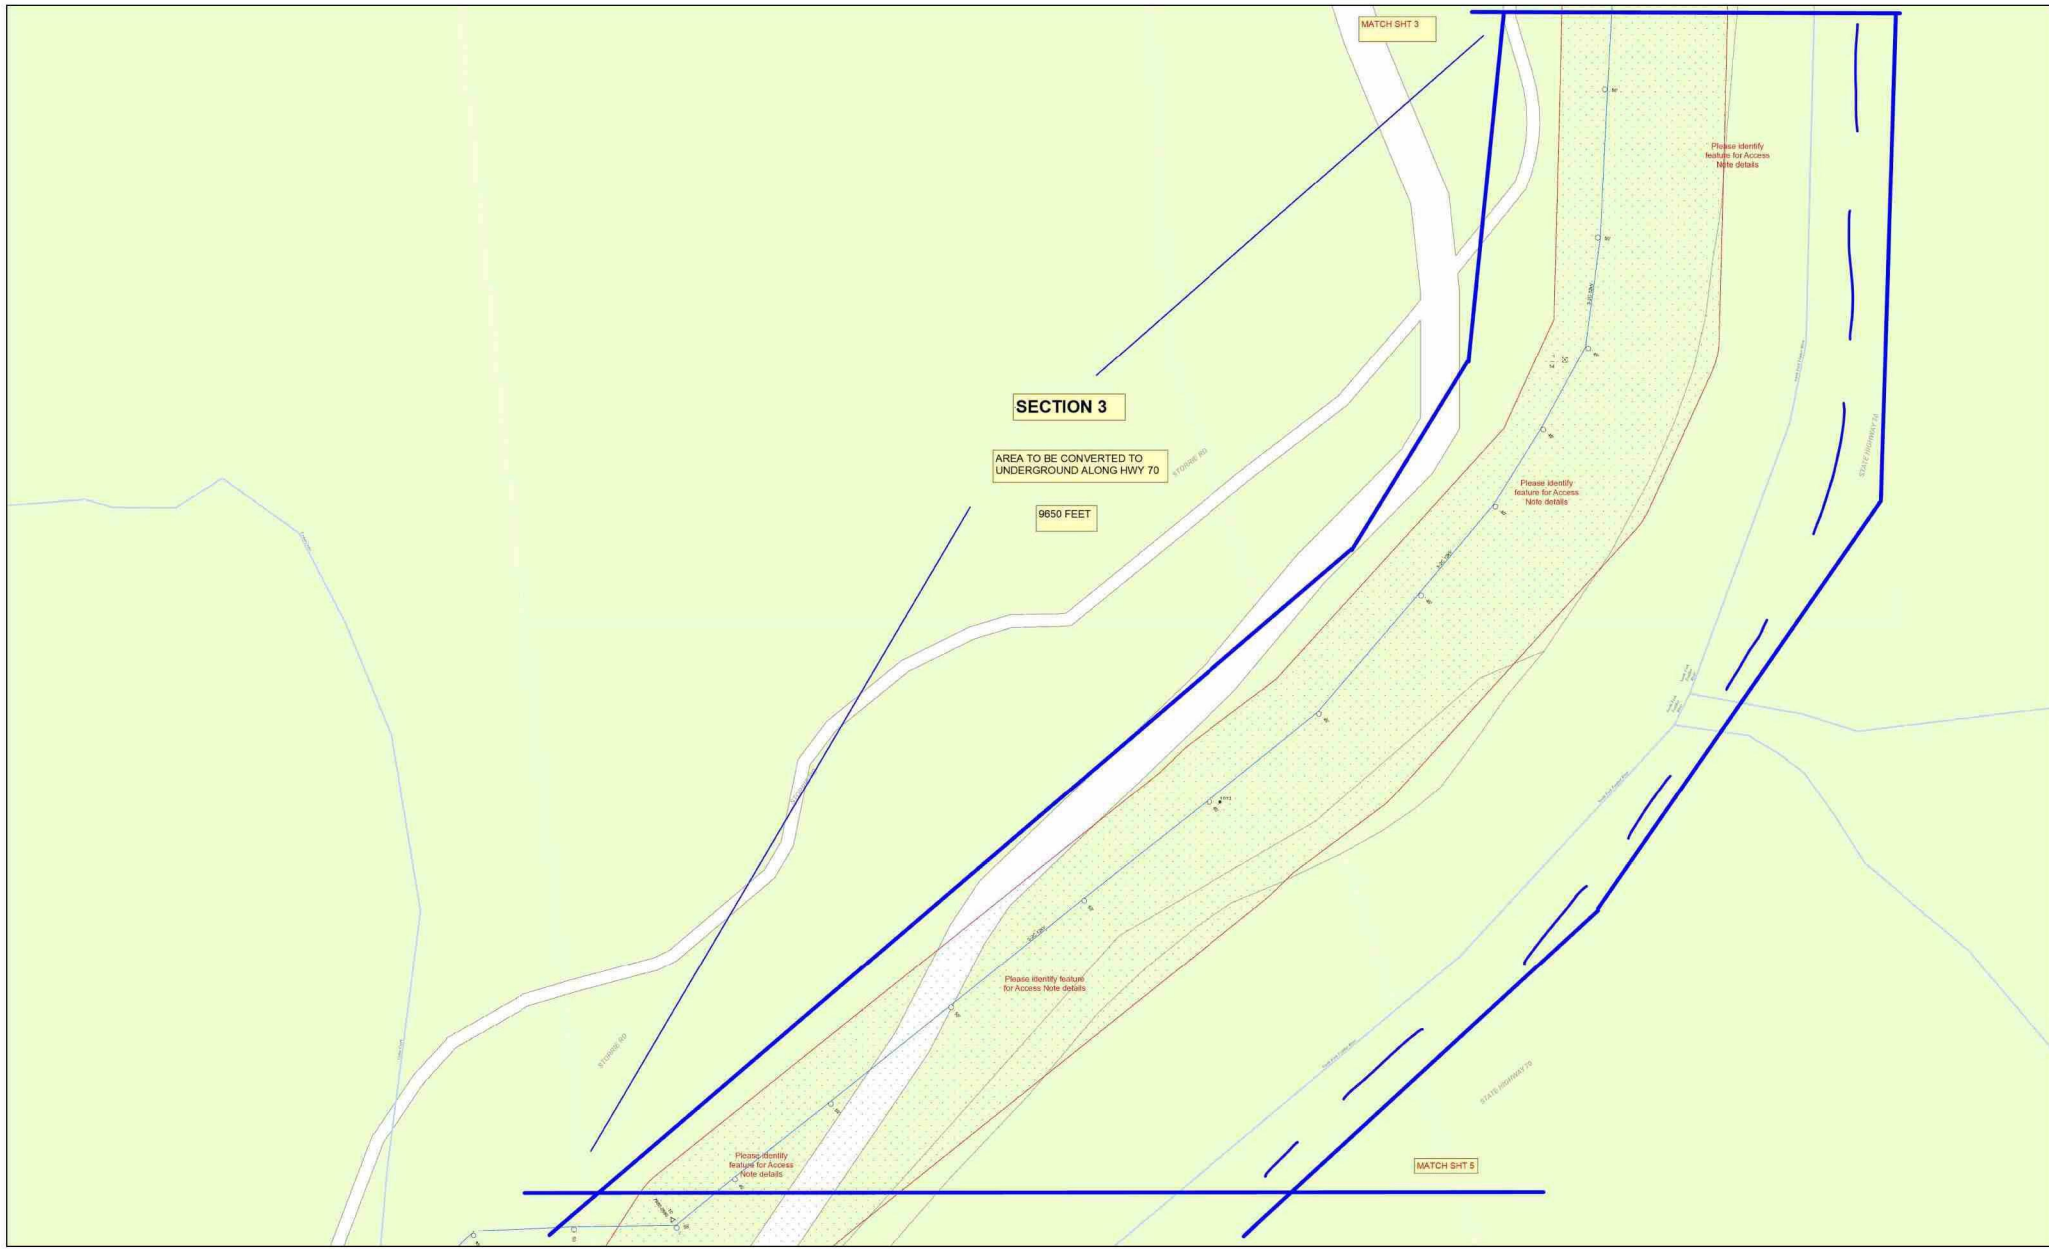
This was on a turn-off along the highway.  
The north side of the bridge has the 50' distance from the  
highway that we would want. We're looking at trenching  
across the highway and replacing the pole where it is.  
The south side of the bridge involves a new riser pole  
next to the highway.
