20210628-18193523042
Electric Drone SubStations Missing Asset - Approver 2021

SUBSTATION FORM

Station: CRESTA PH
Head Quarter: Table Mountain
Date Inspected: Jun 28, 2021 11:58:00 AM PDT
Inspected By: [Redacted]

Asset Type: ETS.TXFR
Equipment: BANK 1 A PH
Is this a Re-Inspection Form?: No

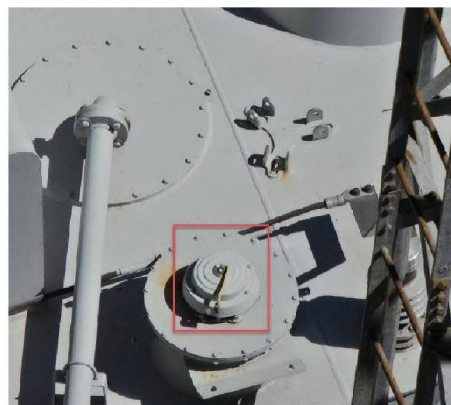
Photo

Does the transformer have PRD? Yes

Is there indication of pressure relief device activation? No

↳ Describe Issue:

↳ FLAG OUT OF ALIGNMENT

Is pressure relief device actuation flag damaged? Yes

Problem Description	BK 1 A PRD FLAG OFFSET
Facility/Equipment	Transformer/Regulator
Type	LTCR
Damage	Damaged
Action	Repair
Priority	B
Required End Date	2021-09-26
Identified in Field During	Station Inspection-DDSI
Clearance Required	Yes
Crew Class (Size)	SUB_ELE2

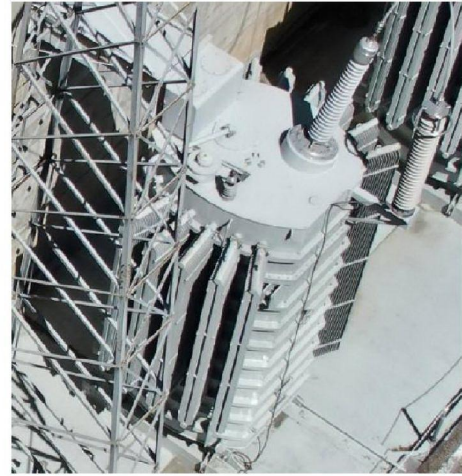
Photo

Any signs of leaks? Yes
Additional consideration may be required for this finding

↳ Describe Issue: ↳ POSSIBLE OIL LEAK

Non Conformances Flag Count (by Inspector)	3
SME Status	Approved
SME Notes	BK 1 A PRD FLAG OFFSET. OIL LEAK. HO IS GROUNDED NO ISSUES
A's	0
B's	2
E's	0
Non Conformances Flag Count (By SME)	2
Inspector Lan ID	[REDACTED]
Select SME (selected by Inspector)	[REDACTED]

Problem Description	BK 1 A OIL LEAK
Facility/Equipment	Transformer/Regulator
Type	Power TXFR
Damage	Leaks
Action	Repair
Priority	B
Required End Date	2021-09-26
Identified in Field During	Station Inspection-DDSI
Clearance Required	Yes
Crew Class (Size)	SUB_ELE2
Est Hours	10
Est. Total Job Costs to Complete in Hrs (labor,materials,rentals, etc. - no travel time)	20
FIELD COMMENTS (Describe the work required and the equipment and the materials needed. For example: Special tools or equipment, any unusual conditions, special circumstances and supporting comments related to other information required)	BK 1 A OIL LEAKS
Select Tier	T3 Drone Inspection
ETS Type	ETS51 Repair & Return
