Subject: RE: Report #1 (Initial) - Dixie, Oroville, Butte County

Incident Report Number: 1 (Initial)

**Incident Type: Vegetation** Incident Name: Dixie

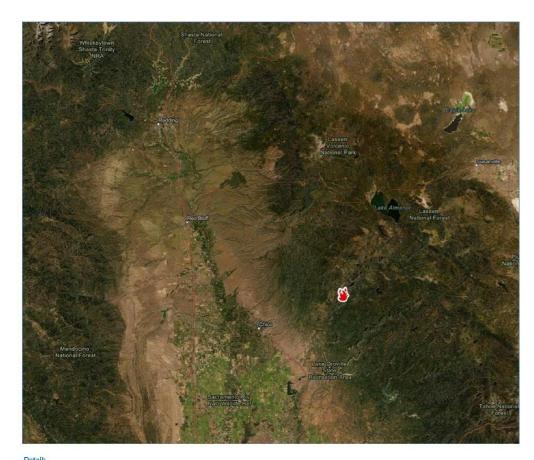
Overview:

The Dixie Fire is approximately 1,200 acres, 0% contained and burning in steep and inaccessible terrain north of Highway 70 and west of Merlin, underneath PG&E's Distribution and Transmission line assets. The fire is come out of the Feather River Canyon bottom and has reached the ridgetop near the Caribou-Table MTN – 230kV lines. The fire is currently burning upslope, upcanyon to the east, northeast and under normal diurnal summertime burning conditions. CAL FIRE is attempting to get ground resources to the ridgetop along the 300 U Line road in an attempt to stop the forward rate of spread using dozers and fixed wing aircraft. This fire is very dynamic and lag time for getting ground resources in place will be the challenge for firefighters.

#### Assets Potentially at Risk:

Distribution: Bucks Creek 1101

• Transmission: Bucks Creek-Rock Creek-Cresta – 230kV, Caribou-Palermo – 115kV, Rock Creek-Poe – 230kV,

Caribou-Table Mtn – 230kV
